## NC Windscreen Cowl Water Leak

Words & photos: Bob de Bont

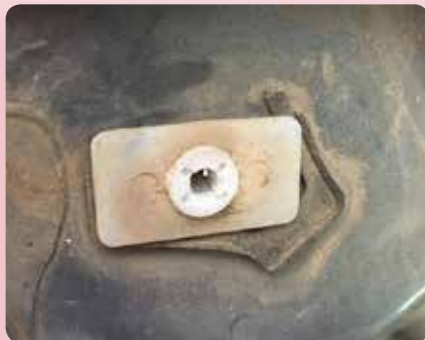
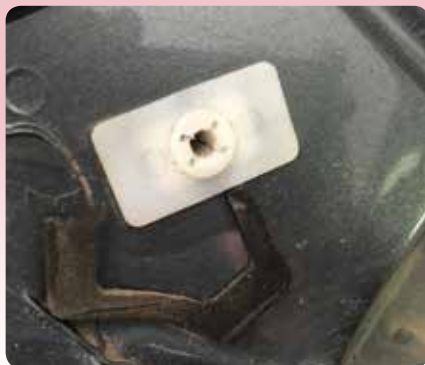
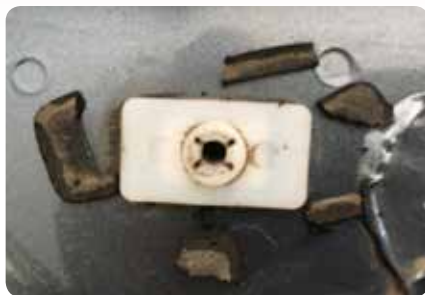
The water leaks through a crappy foam gasket which is supposed to seal the plastic nut used to retain the cowl cover in place.

*However, the gasket perishes with age.*

As you can see, my gasket had disintegrated... especially on the passenger side.

**What makes this leak fairly critical** is the positioning of the interior fuse box *directly under* the plastic nut, allowing some water to drip into the electrics. Water and electric wiring are never a good combination, as many NC owners in the US and UK have discovered.
