MX-5 Short-nose Crankshafts

MX-5 Short-nose Crankshafts (ctd)

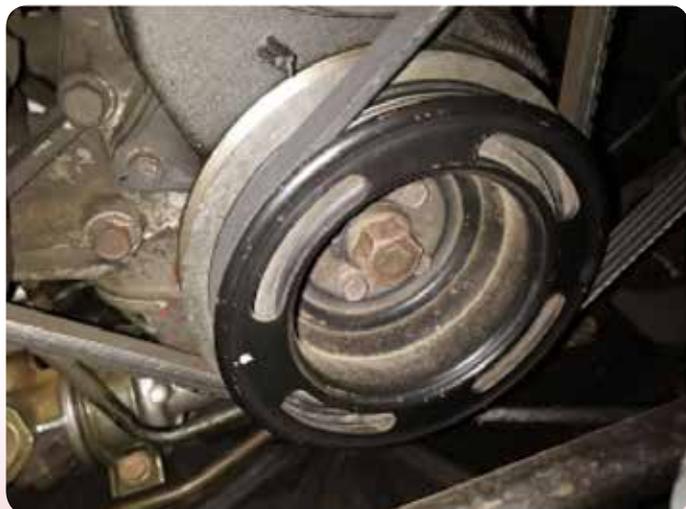
Photo of a four-slot crank pulley = short-nose crank (C Bray)

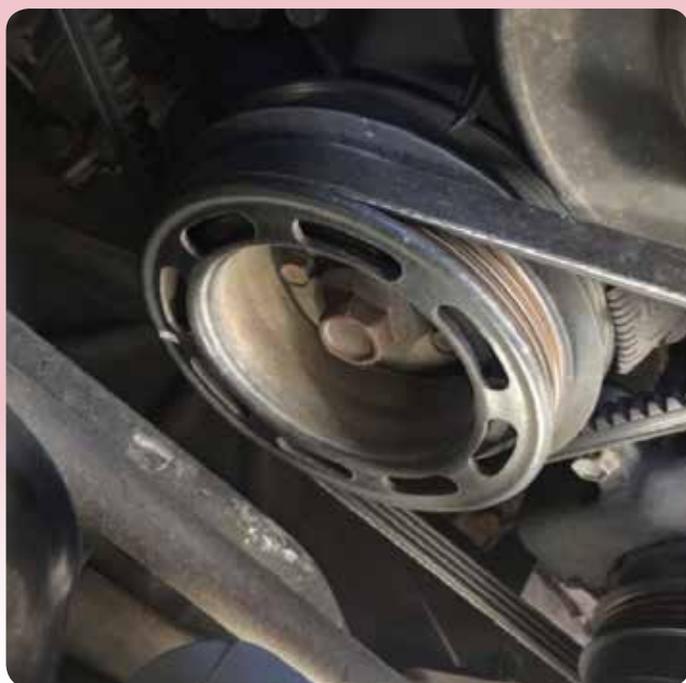
Photo of an eight-slot crank pulley = long-nose crank (P Theodoru)

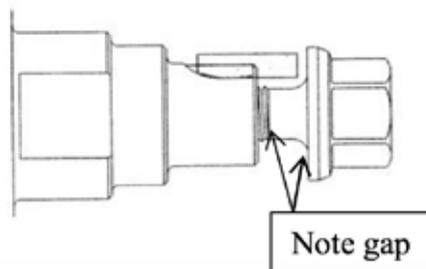
A contributing factor is that the woodruff key is not engaged over its entire length and so if the pulley is not done up to the correct torque, this can also allow movement of the pulley relative to the crank and this can also lead to the keyway flogging out, wear between the crank and the pulley and, ultimately, crank failure.

Sketch of "short-nose" crank showing unsupported part of woodruff key (Schall article)

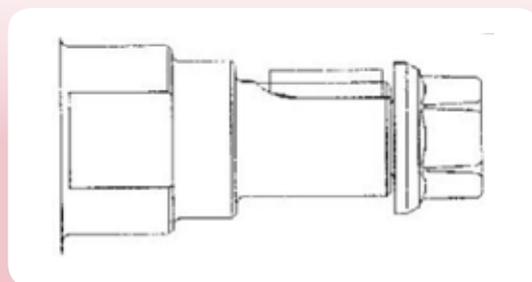
Detail on the "long-nose" crank – note that crank extends forward to rear of bolt and bolt is 40% larger in cross section. Note also that tightening torque differs to short nose (Schall article)

It is important NOT to use the 120 ft-lbs setting that is used on the long-nose crank as the bolt diameter is different – the later unit for the long-nose crank has a 40% greater cross-section.

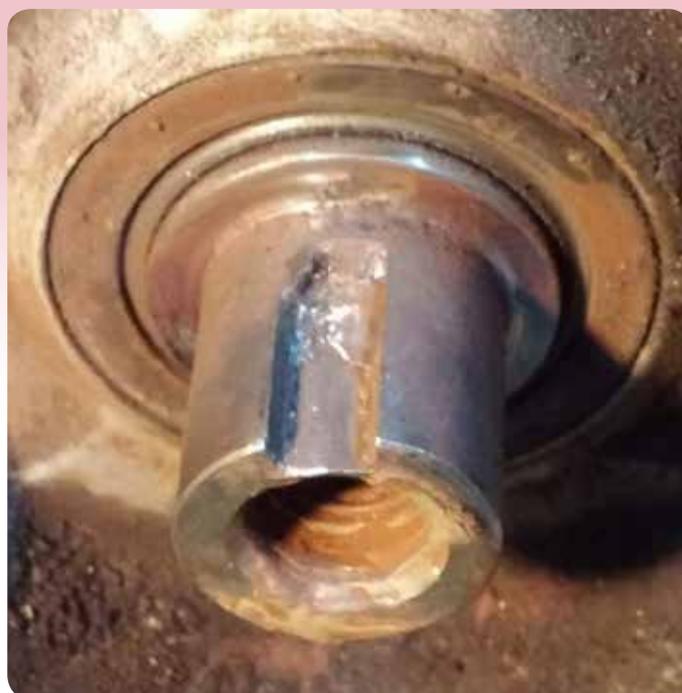
There is nothing actually wrong with the design but it is somewhat unforgiving and it's easy to stuff up reassembly and, in so doing, allow movement which flogs out the keyway and then allows cam timing to drift, over time.

Flogged out keyway after woodruff key has moved in keyway of crankshaft – note original width at extreme rear, note also that wear is one side only – this is important if doing the "Loctite repair"

There are other fixes that some have undertaken when finding damage to the keyway:

- » Machine a wider keyway – possible but needs the crank out of the engine.
- » Hand carve a wider keyway with the engine IN the car – it's been done, but it's a *mongrel job* and needs extreme care to ensure cam timing is not compromised. (I know of one case that took 11 hours of painstaking work under the car!)
- » Do the "Loctite fix" (see below).
- » New crank with long nose.
- » I have personal experience from another Mazda, many years ago, of welding the crank and cutting a new keyway – when the end of the crank subsequently fell off due to embrittlement at the weld, I was unimpressed! *Not recommended.*

If repairing the keyway, he sets out how to measure the wear and what Loctite to use if going this way. If you have this crankshaft issue, it's worth the cost of the book to get his method – it is a multi-stage measure and repair and it involves the use of both *Quick Metal* and *Loctite 242* (243 seems to have replaced 242 now) to:

- (a) repair the slot and
 - (b) close gaps between the cam gear and the crank (these may have arisen due to movement between the two).
3. *YouTube* is also an excellent resource with lots of useful videos but **remember**, it's *YouTube so not everything is correct, authoritative, relevant to the Australian experience or good engineering practice! ■*

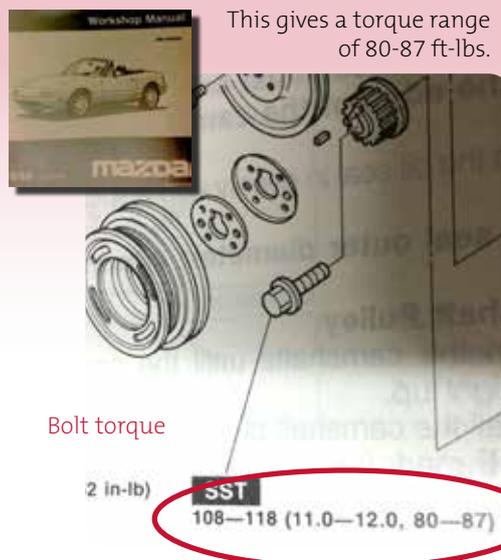
This gives a torque range of 80-87 ft-lbs.
