Check those drainage holes!

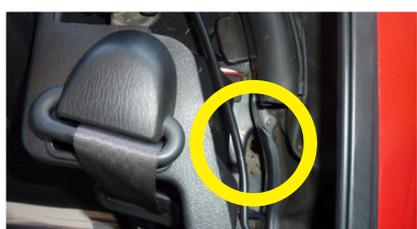
In the NA and NB, the top of the drainage tube is a circular hole about the diameter of a bloke's index finger, situated in the "nook" where the soft top roof hinges on the body. It's right between the seatbelt tower and the car's side bodywork.

However, it's hidden under a small flap of rear sill carpet. To access it easily, you need to fold back this carpet flap.

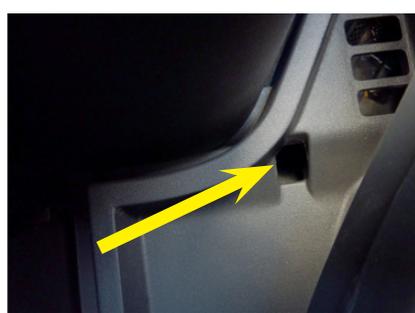
In the NC, the arrangement is much more civilised, and the rectangular draining hole can be seen clearly behind the seatbelt tower, and accessed very easily.
