## Replacing the clutch ...

Words & photos: John Waldock

**Last year my NB SE began to make quite pronounced throw bearing noises on gear changes.**

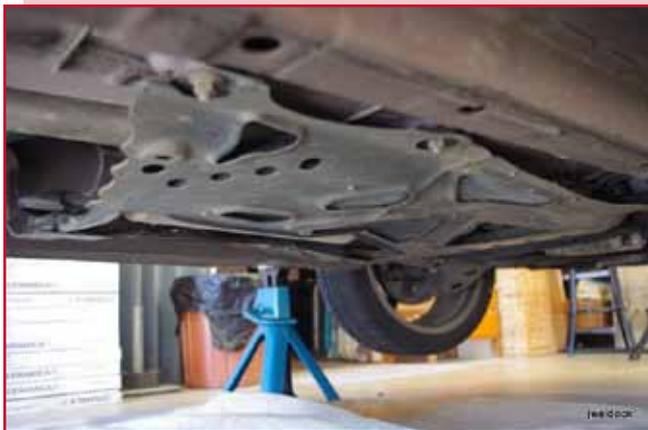
*Mid-chassis brace*

Once the car was up, we took off all the wheels to get easier access under the car. To access the gear box, there are a number of things that have to be removed from the car. Under the car, there are a number of chassis braces and other components which are in the way. There is a mid-chassis brace, a bar in front of the brace, a brace near the differential and a bar in front of the rear brace. These are all held with large bolts, fairly easily removed but a slow process. They will have some road muck on them no doubt, and small deposits of oil too. We removed these, cleaned with

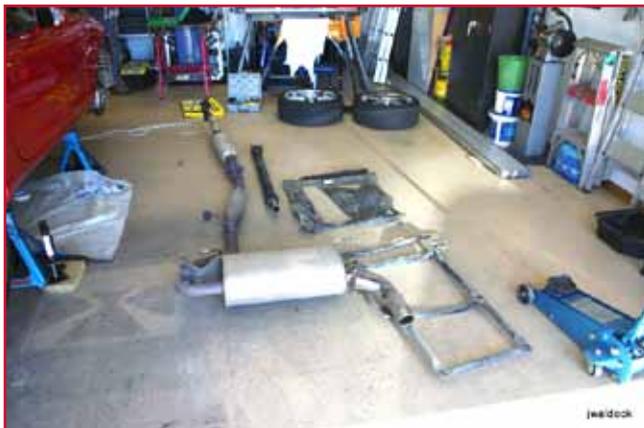
*Braces, exhaust and tail shaft removed*

The exhaust needs to be removed; there are three bolts that connect it to the exhaust manifold, and they can be tricky to remove so buy some lubricant spray such as CRC or WD40. There is also a bracket with two bolts that needs to be removed.

Since we didn't fully remove the PPF, we pulled it sideways and held it away with wire. Not ideal, but it did work and saved us some headaches with the rear bolts. You will need to remove the tailshaft; it's held on with four bolts, which allow it to be lowered and pulled away from the back of the gearbox.

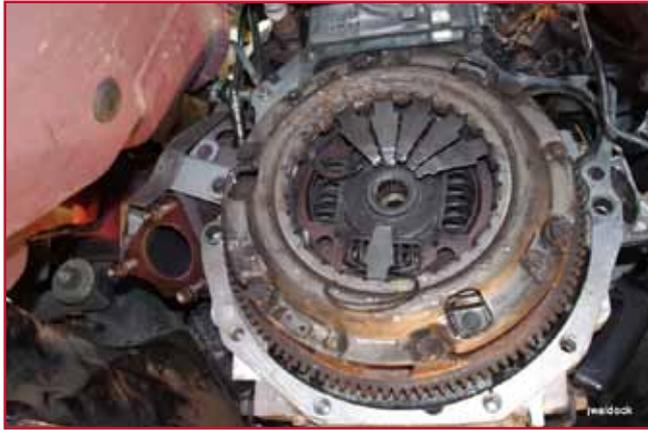
*A very chewed-up pressure plate*

We replaced not only the clutch, but also the throw bearing and the pressure plate itself, as the old one was damaged when the throw bearing failed. You should also look at the rear engine seal, as this can leak oil and its easy and cheap to replace while you're there.

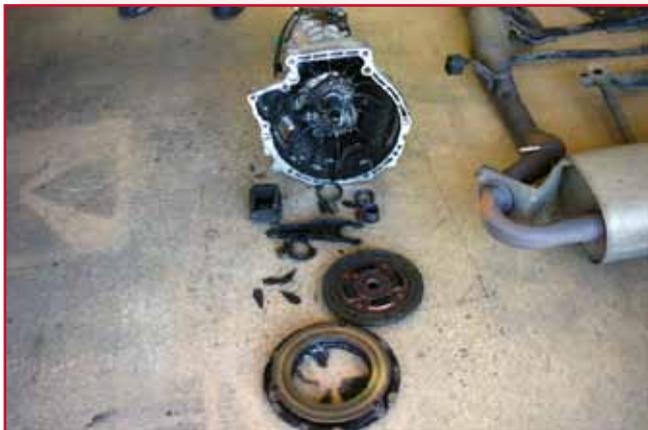
*What a mess!*

A note of caution: I did let my throw bearing get pretty much chewed up before I replaced it and I definitely don't recommend that you drive your car to the point that the bearing fails. The failed bearing parts made a mess inside the clutch and bellhousing as the photos illustrate only too well. ■

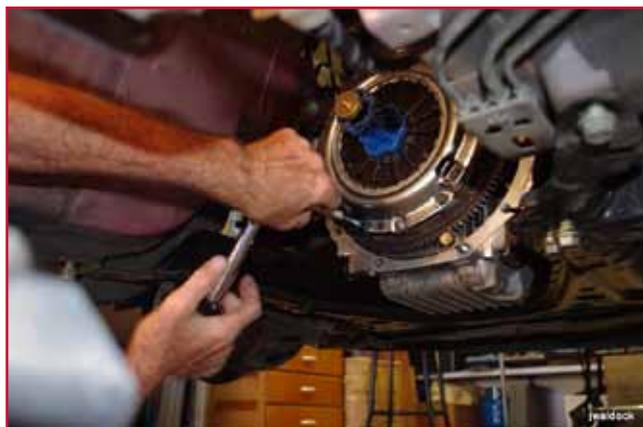
*New clutch and bellhousing, with clutch alignment tool*

The next stage is to use the clutch alignment tool to slide the clutch and pressure plate into place. We found a really useful clutch tool from the UK which holds the clutch and pressure plate together as you slide them into place. As these are centred, they need to be aligned *carefully* or excessive vibration can occur. Bolt the pressure plate back

into place. Reattach the bolts, again using a tension wrench.

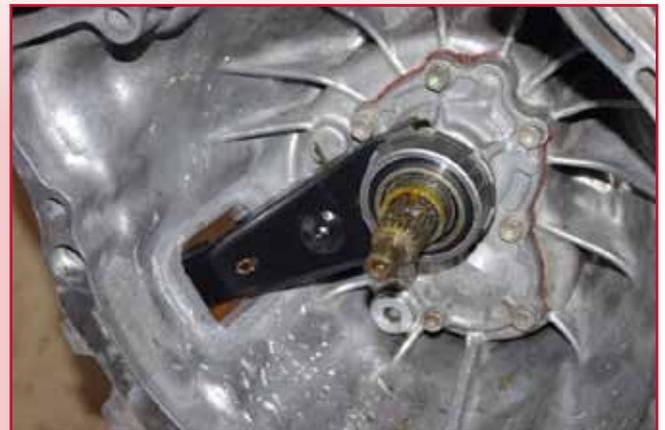
*Throw bearing*

The next step is to put the gear box back in. You will need to clean the clutch fork arm and put it back in place with the rubber boot. *Do this before you put the gearbox back in; you will need some room to do it.* Slide the throw bearing onto the spindle. We put some general grease on the spindle to make sure the bearing slides along nicely. Now slide on the new boot.
