## Water leak in your NA?

### If you own an NA MX-5, this is worth a read.

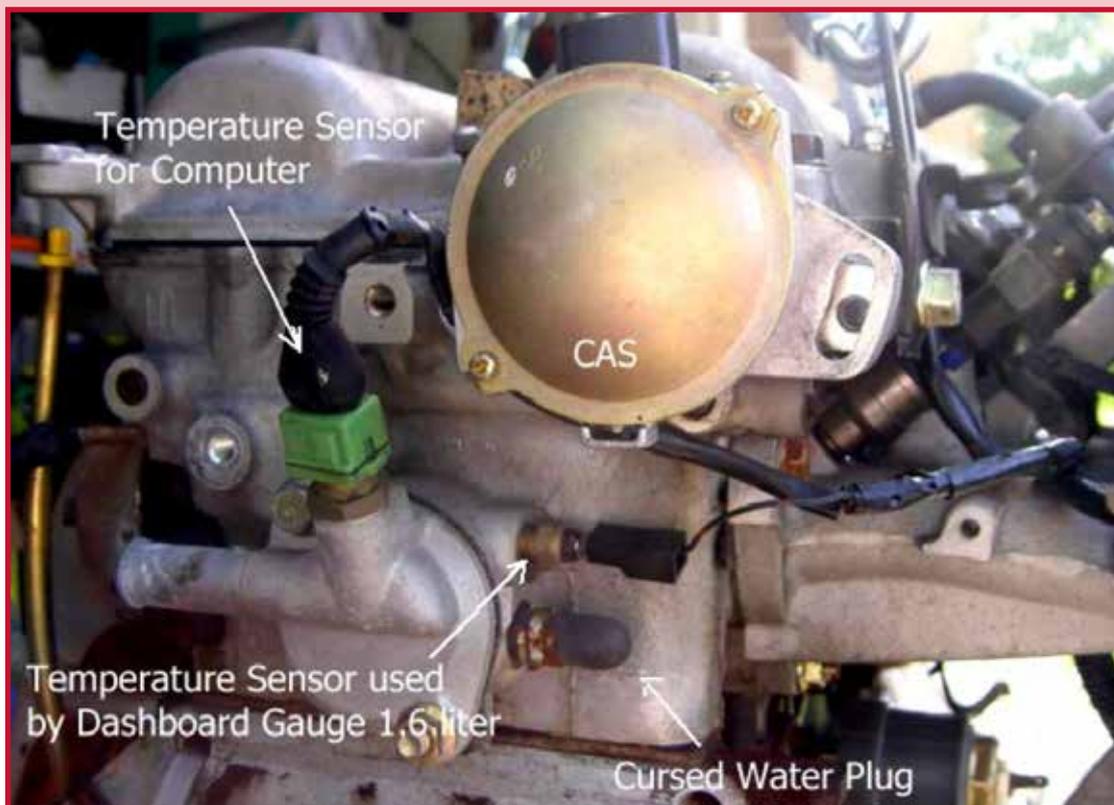
It turns out there is a rubber blanking plug at the rear of the head, under the cam angle sensor (CAS) which

I was totally unaware of. This was the culprit!

**The removal and fitting were something else!** I searched a few US sites and found them saying the job was hard. But they don't have steering, a brake booster and brake lines and clutch cable in their way – we do! The main photo below, "borrowed" from *miataturbo.net*, shows the detail at the rear of the head.

The only way I could find to do the job was to remove the CAS (after marking its position for re-fitting), getting the CAS out of the way (which involved removal of rear engine lift point and then a lot of cursing!), then using my left hand and a small pair of needle nosed pliers from the side, and right hand from the top, easing the hose off the fitting.

Putting the new hose on to the fitting on the head was straightforward and I used a long socket over it to get a bit more purchase to push it on.

I ended up fitting a good quality stainless steel jubilee clip with hex head drive and a ¼" drive socket, with universal joint and long extension, from the top, to do it up.
