## Radiator pipe rubbing point - all NCs

Words: Bob de Bont

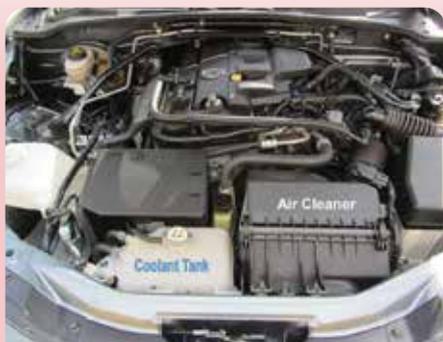
Loosen the two clamps holding the rubber hose between the air cleaner and the inlet manifold.

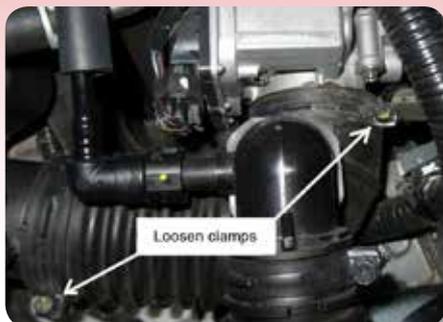
Undo the two clips holding the air cleaner box together.

Carefully manoeuvre the air filter box apart and carefully disconnect the cable retaining clip.

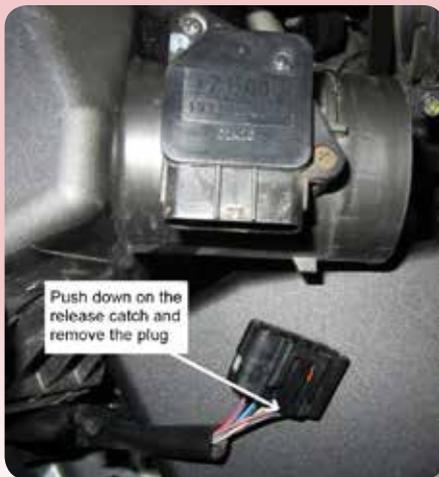
Pull the air cleaner box free and also remove the air filter.

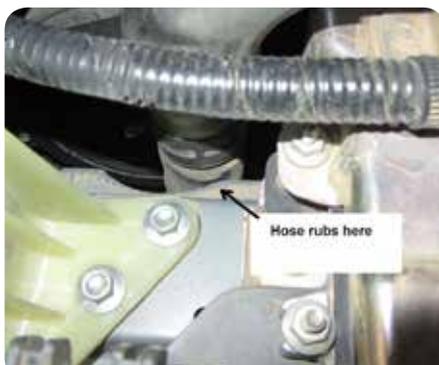
The chassis has a curved cut-out to allow the hose to clear; however, during assembly, the pipe is not positioned correctly resulting in it rubbing against the seam. *How much it rubs and how quickly it will wear through the pipe in your car is anyone's guess!*

Repositioning the hose in the large white nylon clip won't permanently move the pipe as the clip doesn't hold the hose securely which is why it squeaks.

A suitable lubricant can be applied to the clip to stop the squeak.

I positioned about 50mm of PVC Pinchweld Protective Edge Trim (available from Clark Rubber #28) between the pipe and the body.

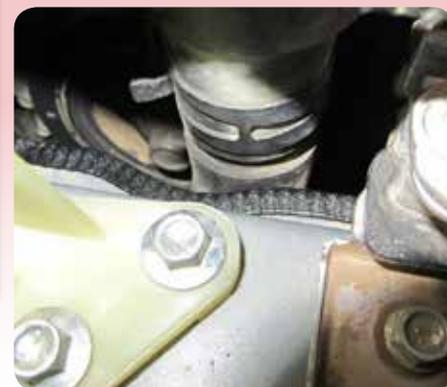
Others have sliced open some garden hose and glued that in place as an alternate.

If the rubbing is severe, it would require the various radiator hoses to be loosened and repositioned to align the pipe in the correct position.
