## NA Model Heater Leak

Words and photos: Peter Ferguson

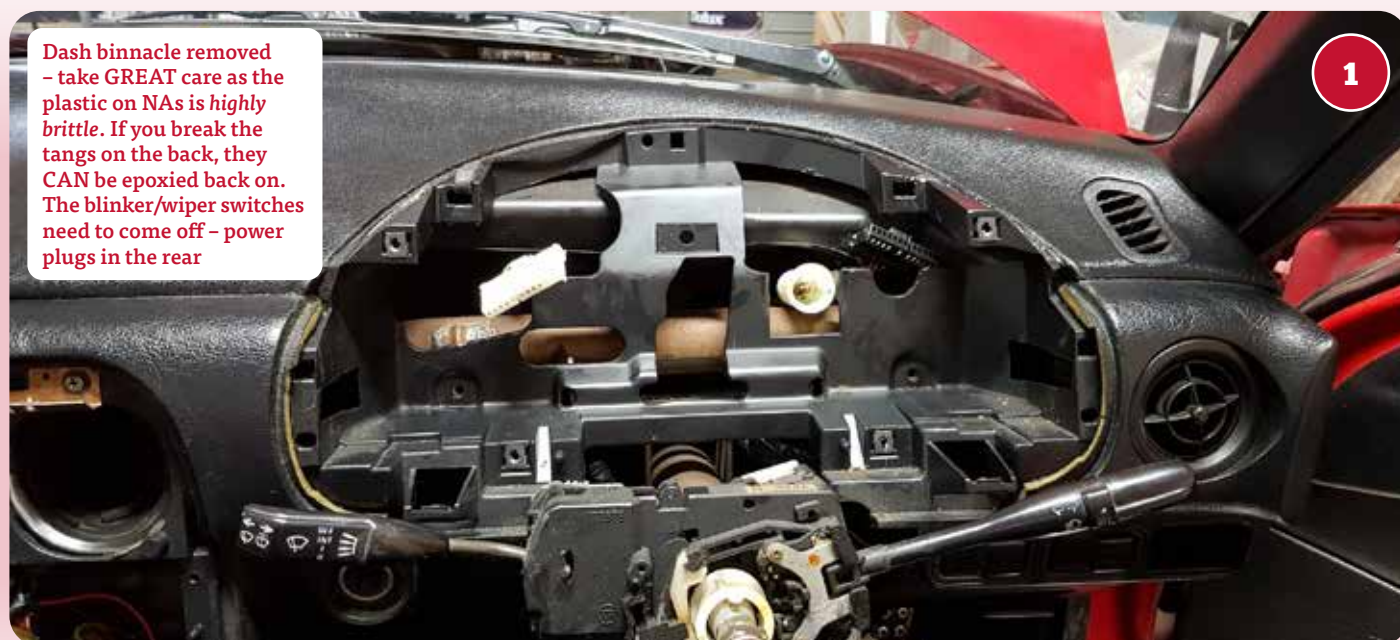
1

Dash binnacle removed - take GREAT care as the plastic on NAs is highly brittle. If you break the tangs on the back, they CAN be epoxied back on. The blinker/wiper switches need to come off - power plugs in the rear

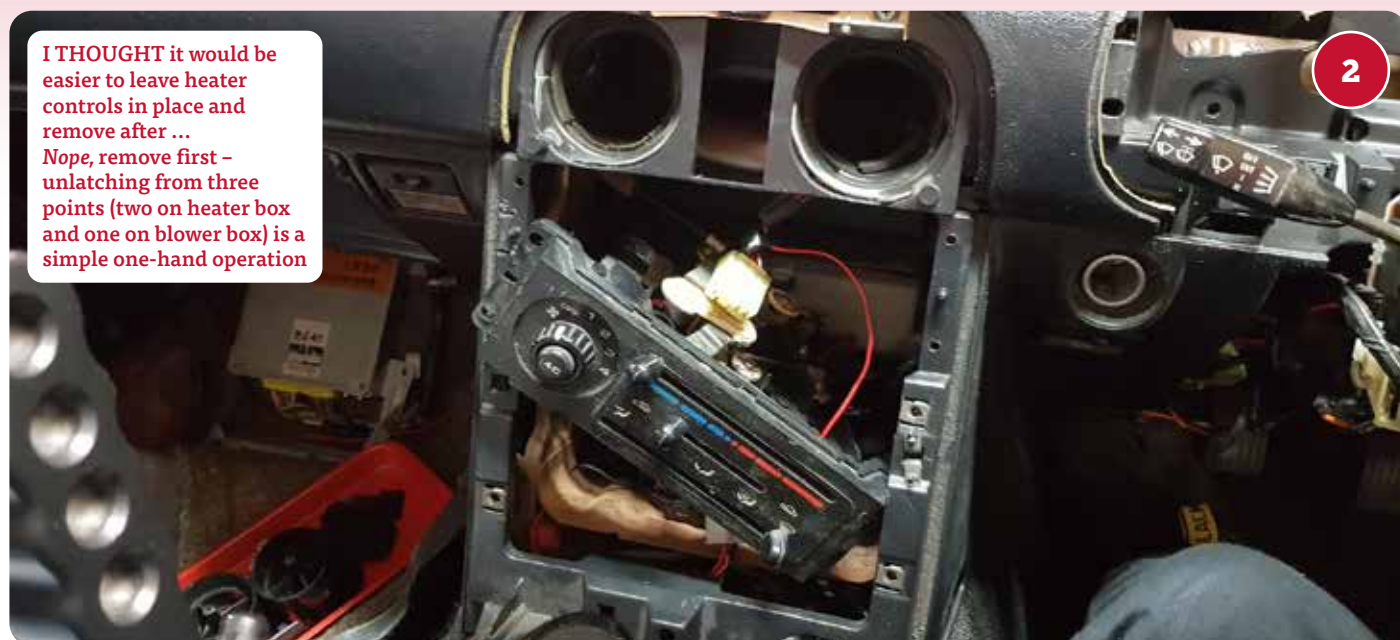
2

I THOUGHT it would be easier to leave heater controls in place and remove after ... Nope, remove first - unlatching from three points (two on heater box and one on blower box) is a simple one-hand operation

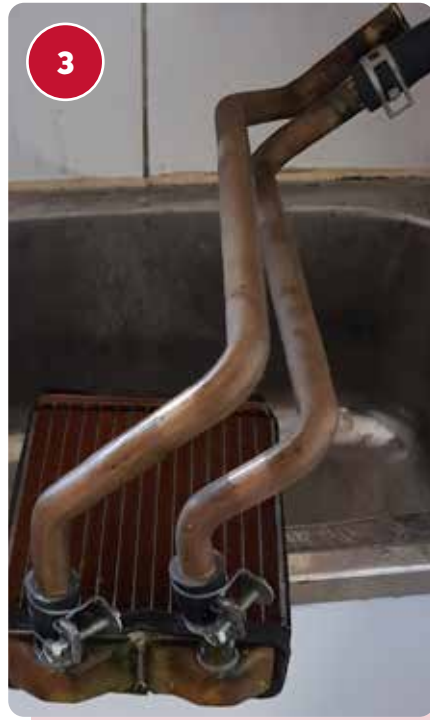
**Above: Heater core and outlet copper hoses after pressure testing. Note that the rubber connector tubes may be over 30 years old and were still in good condition**

I left the joiner hoses and copper pipes on, and set up a test where I could pressurise the unit to about 20psi and spray some soapy water on to the core to find the leak. *Hmm ... no sign of a leak*, so I sprayed the

two short rubber hoses which join the copper lines on, and there was the leak on one of these.

The short hoses appeared to be in perfect condition (but I replaced them anyhow); however, on removing the hose from the heater core, there was a lot of “gunge” on the outlet pipe of the heater core ... indicating it had been weeping for a long time.

So out with the emery paper to clean up the pipe ends, fit new hoses, re-use the hose clamps, fit it all up and re-test – *perfect, no leaks*.

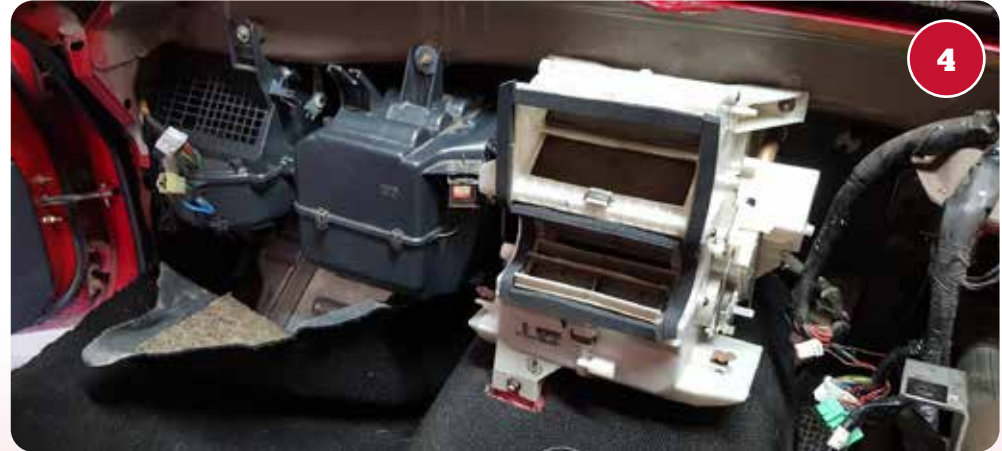
**This is what the back of the firewall looks like once the dash is removed: the box on extreme left is blower and selector for fresh or recirc air; the box in centre is the A/C unit, the white box on right is the heater unit. See plastic cover plate on extreme right of this box with wiring harness beside it and clutch pedal obscured. Removing this cover plate gives access to heater core and pipes**

On the side of the box (adjacent to the clutch pedal) there is a plastic cover plate, and under it is the end of the heater core and its two outlets which connect to the two long copper pipes (photo #3) that run across the back of the heater unit, bend 90 degrees and go through the firewall to connect to the heater hoses in the engine bay.

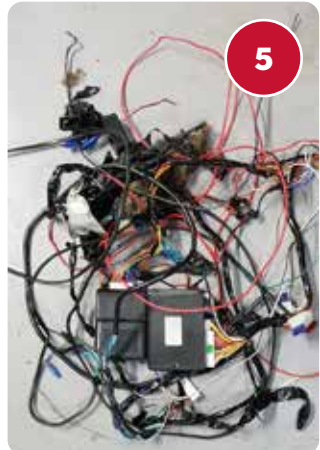
**The pile of useless ancillary wiring, alarm and auto window closers which was all behind the dashboard and woven in and out of EVERYTHING.**

**After removal I crossed my fingers and hoped the car would start and everything would work – amazingly, it did!**

Once all the unnecessary wiring was removed (see photo #5), I could pull the dash right back and get to the problem. Removal of the heater unit is easy once
